ORIGINALLY ISSUED
January 1945 as
Memorandum Report L5A04a

MEASUREMENT OF FLYING QUALITIES OF A DOUGLAS A-26B AIRPLANE

III - STALLING CHARACTERISTICS

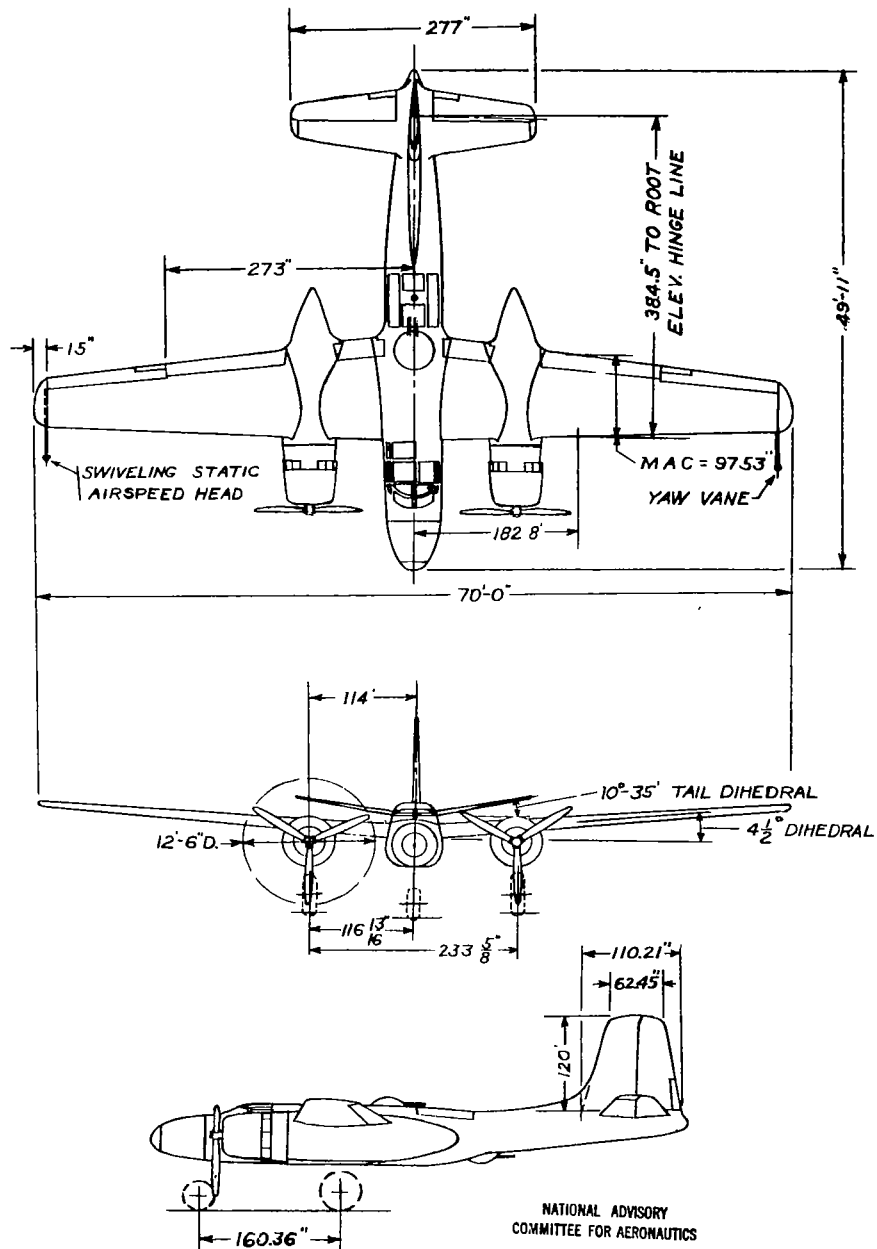
Figure 1.

(a) Three view drawing of Douglas A-26B airplane.

Figure 1 shows a three-view drawing of the airplane and sections of the wing and tail surfaces. A description of the airplane and several photographs of the airplane are given in reference 1. Figure 2 presents photographs of the wing surface condition and the oil-cooler air intake. Figure 3 is a side-view photograph of the airplane showing the location of the service airspeed head. The airplane was equipped with double-slotted flaps. Figure 4 shows a section of the flap at various deflections.

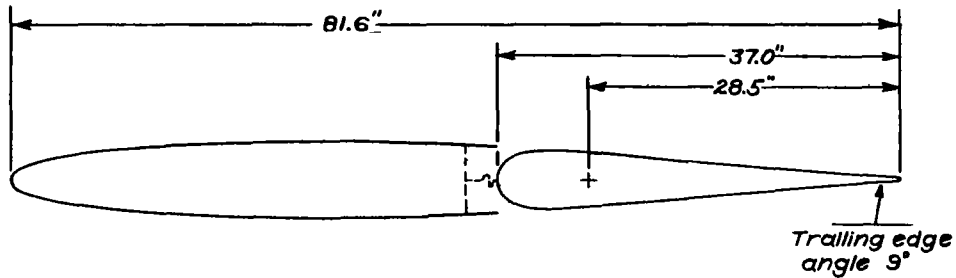
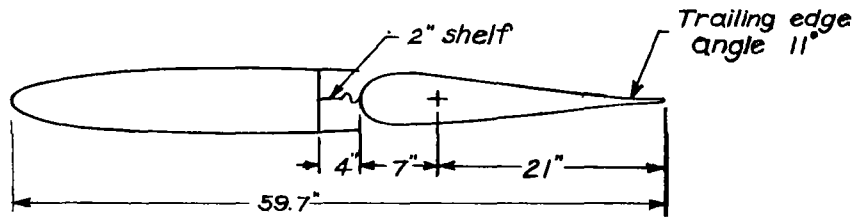
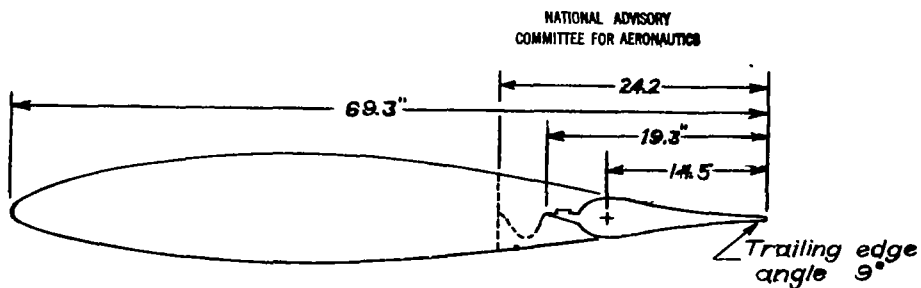
Figure 1.- Concluded.

Section vertical tail 49 inches from tip

Section of horizontal tail 76.5 inches from airplane center line

Wing section 352 inches from airplane center line

(b) Sections through vertical tail, horizontal tail, and wing at aileron. Douglas A-26B airplane.

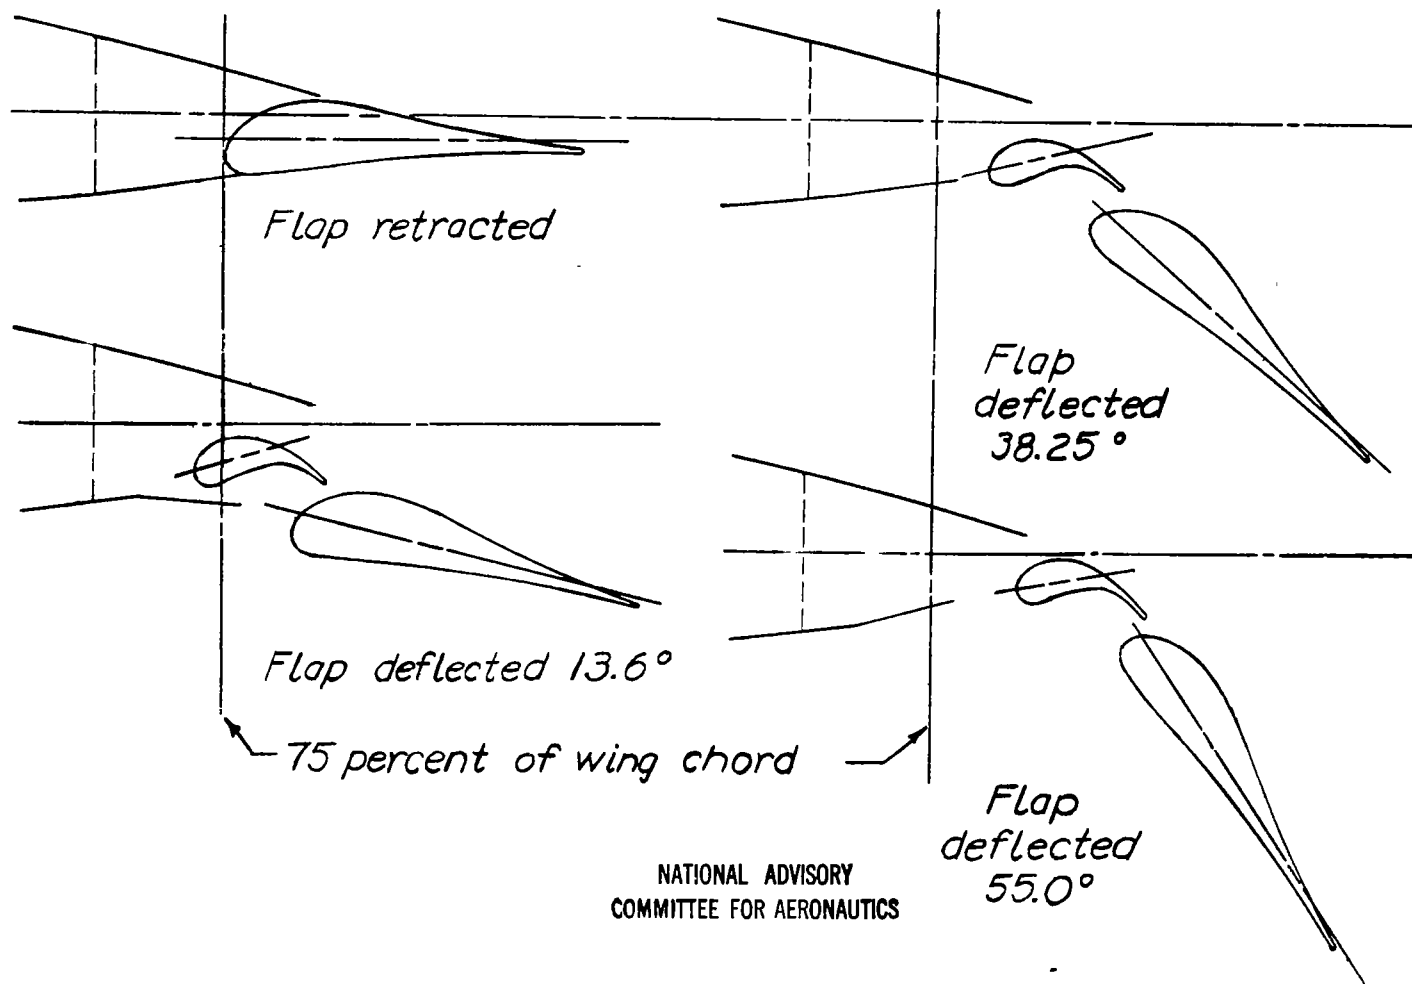
Figure 4.- Section through flap at various deflections.

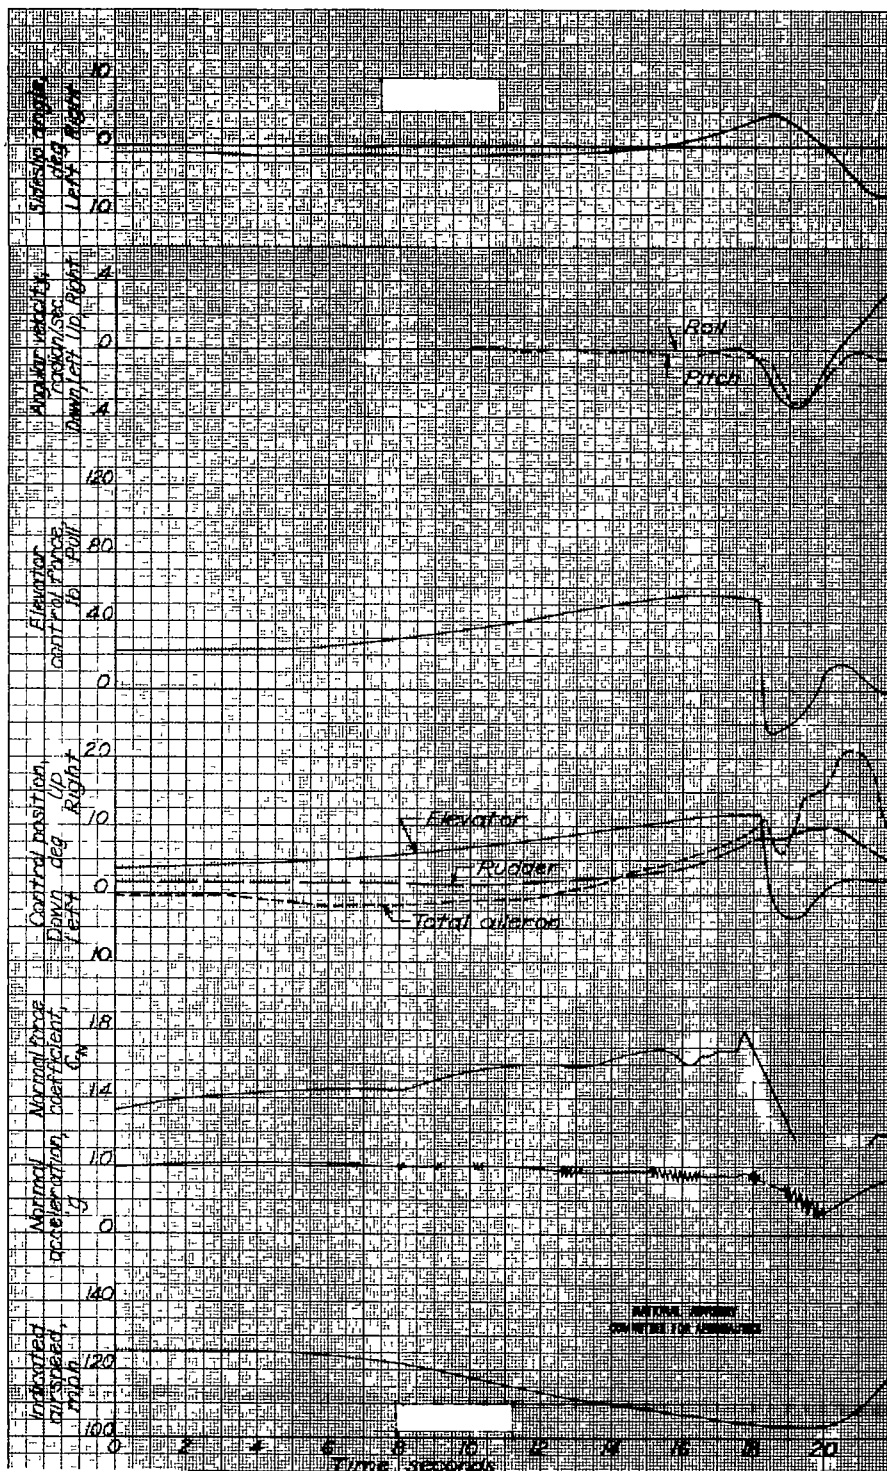
Figure 5.- Time history of a stall in the rated-power clean condition (flaps up, landing gear up, cowl flaps closed, oil cooler one-half open, 41.5 in. Hg. at 2400 rpm, c.g. at 23 percent M A C), Douglas A-26P airplane.

The straight-flight stalling characteristics were investigated in the rated power-clean, cruising, gliding, approach, landing, wave-off, and take-off conditions. The stalls were made by gradually reducing the airspeed while attempting to hold straight flight. Figures 5 through 8 are time histories of stalls in the rated power-clean, gliding, landing, and wave-off conditions. Figures 9, 10, and 11 are tuft studies showing the stall progression over the wing in the gliding and landing conditions, and in the flaps-up condition with one propeller feathered and the other engine delivering rated power. The reason for including a tuft study with one propeller feathered was to make possible a comparison with wind-tunnel studies of stalling over the lip of the wing duct which were made with propellers removed. Tuft studies were not made with power on, because the A-26B airplane climbed away from the observing airplane in the stall approaches.

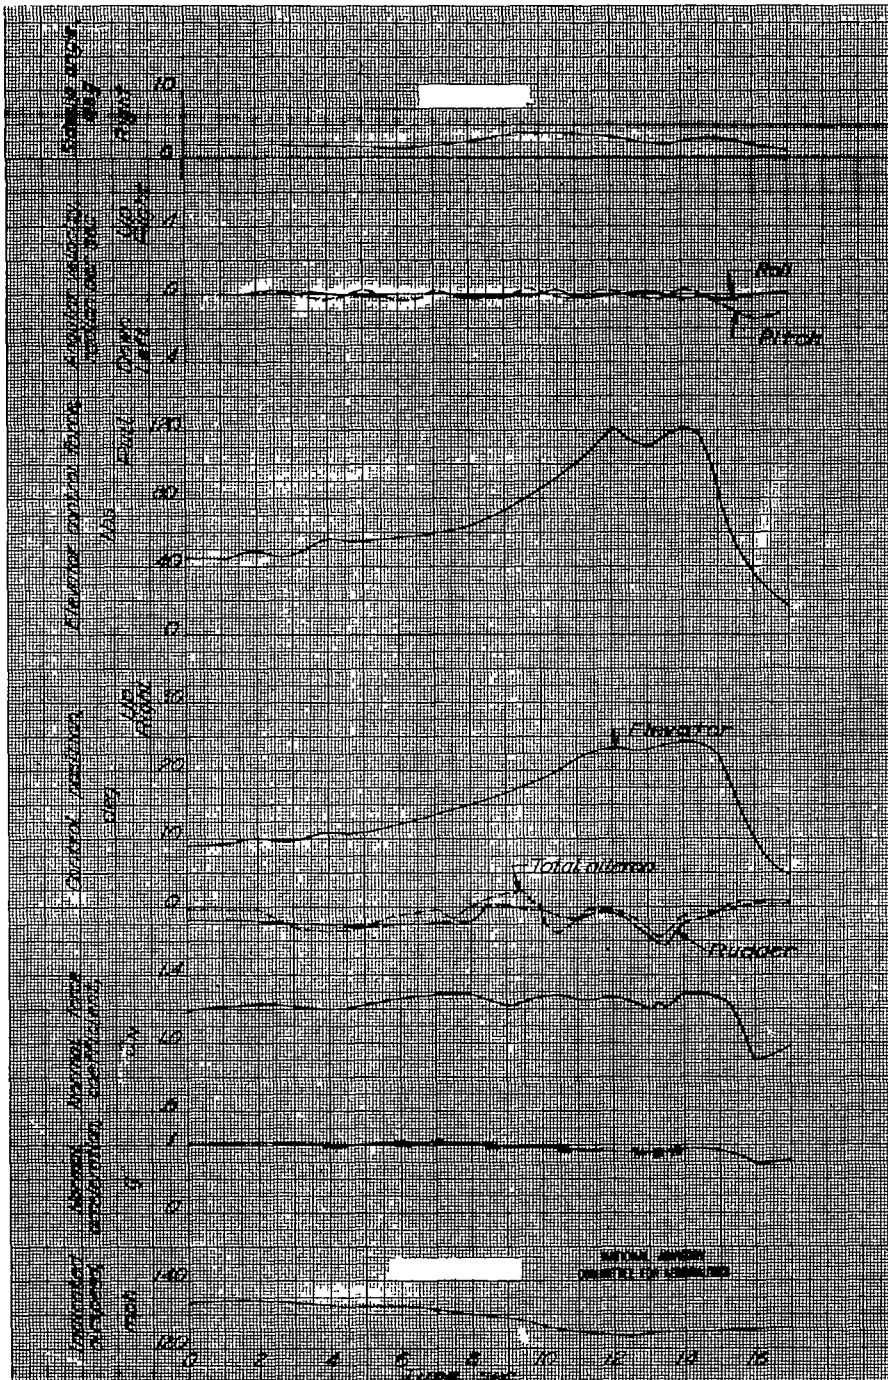
Figure 6.- Time history of a stall in the gliding condition (flaps up, landing gear up, cowl flaps closed, oil cooler one-half open, engines idling, c.g. at 23 percent M A C), Douglas A-26F airplane

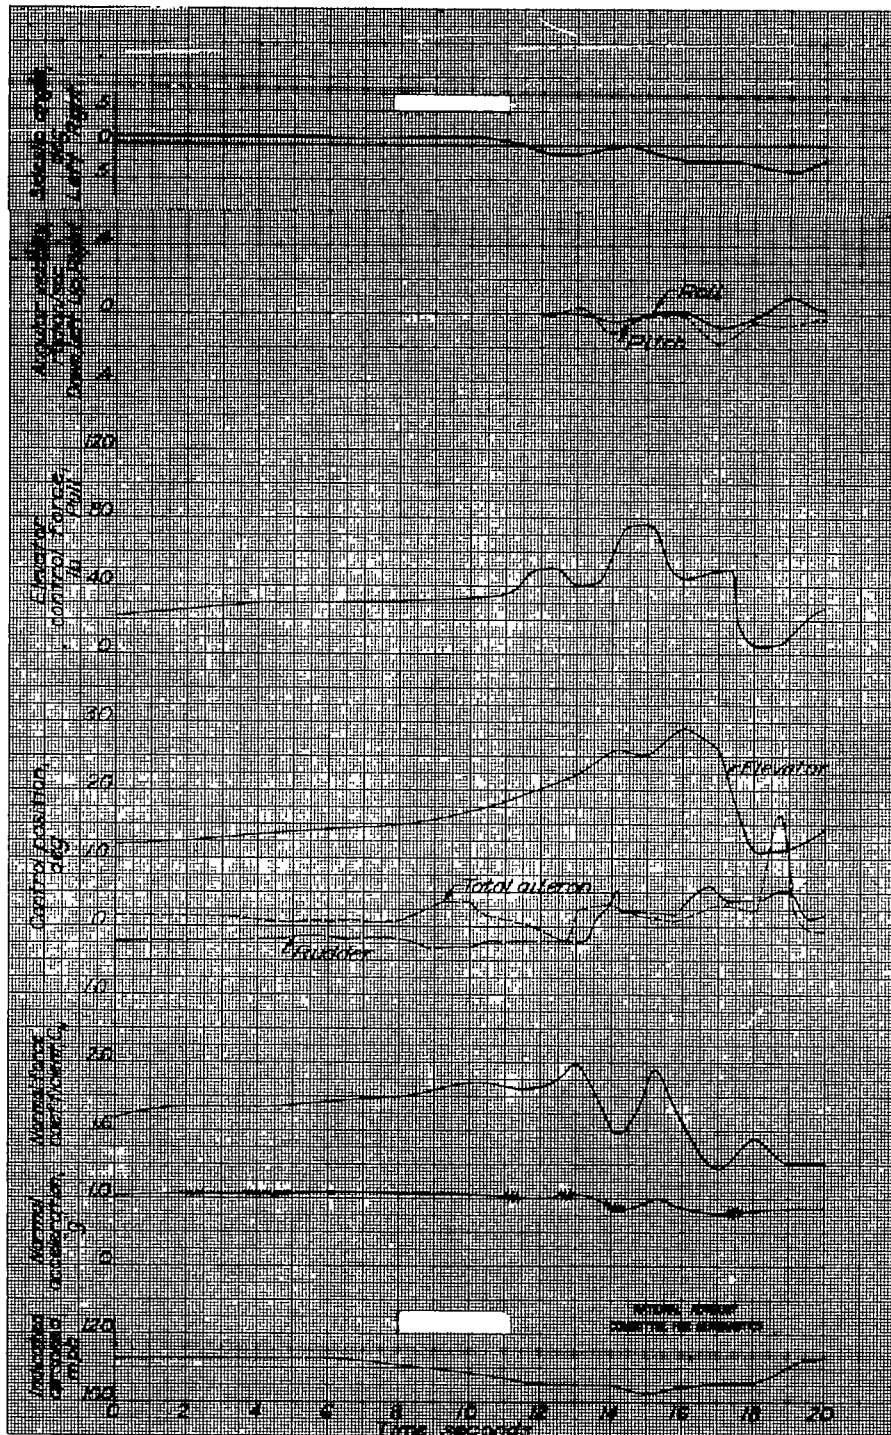
Figure 7.- Time history of a stall in the landing condition (flaps down, landing gear down, cowl flaps open, oil cooler one-half open, engines idling, c g at 23 percent M A C) Douglas A-26B airplanes.

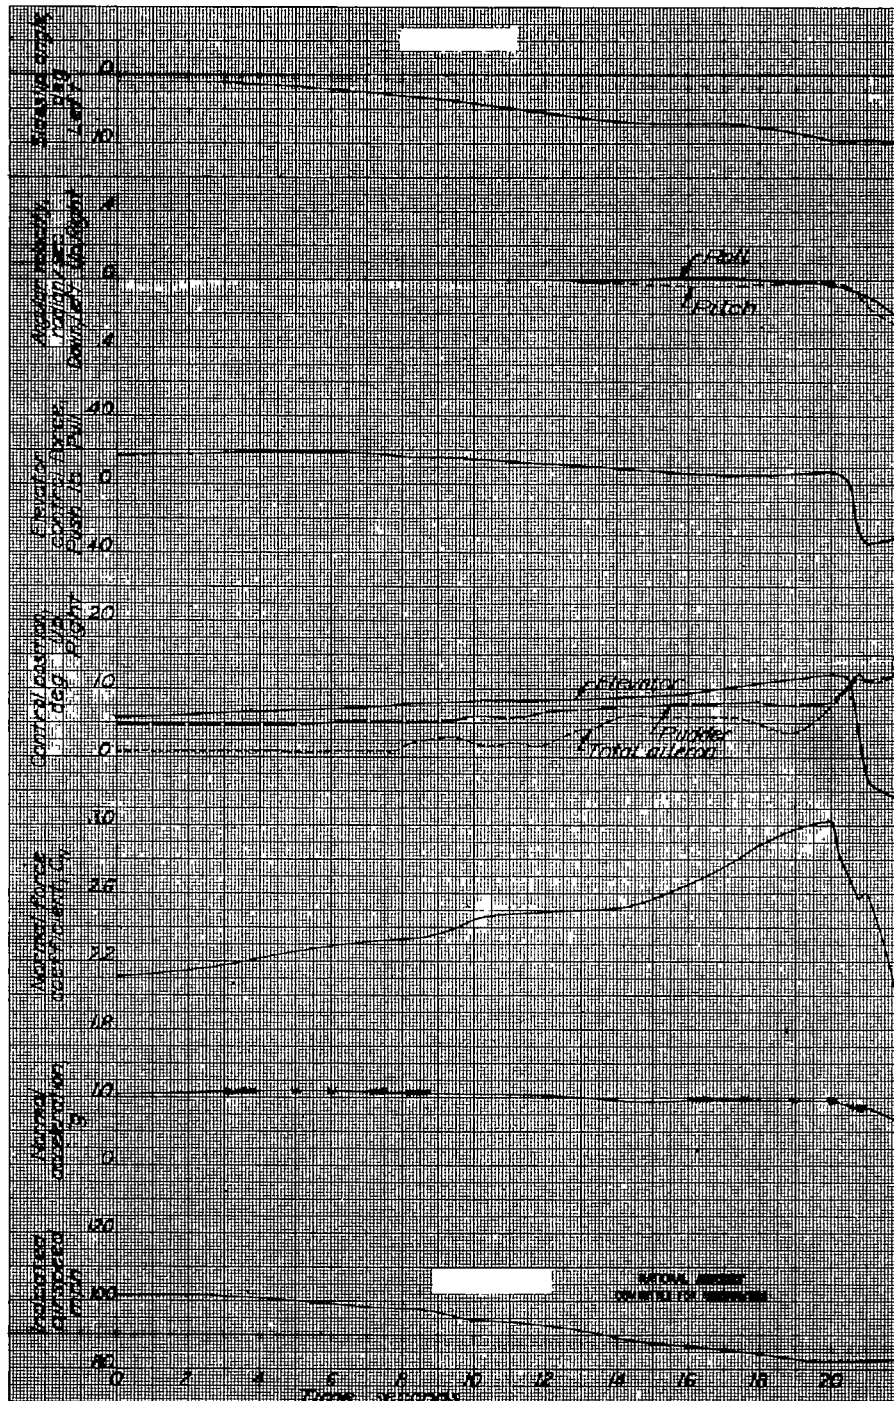
Figure 8.- Time history of a stall in the wave-off condition (41.5 in. Hg. at 2400 rpm, flaps down, landing gear down, cowl flaps open, oil cooler one-half open, c.g. at 23 percent M A C), Douglas A-26B airplane.

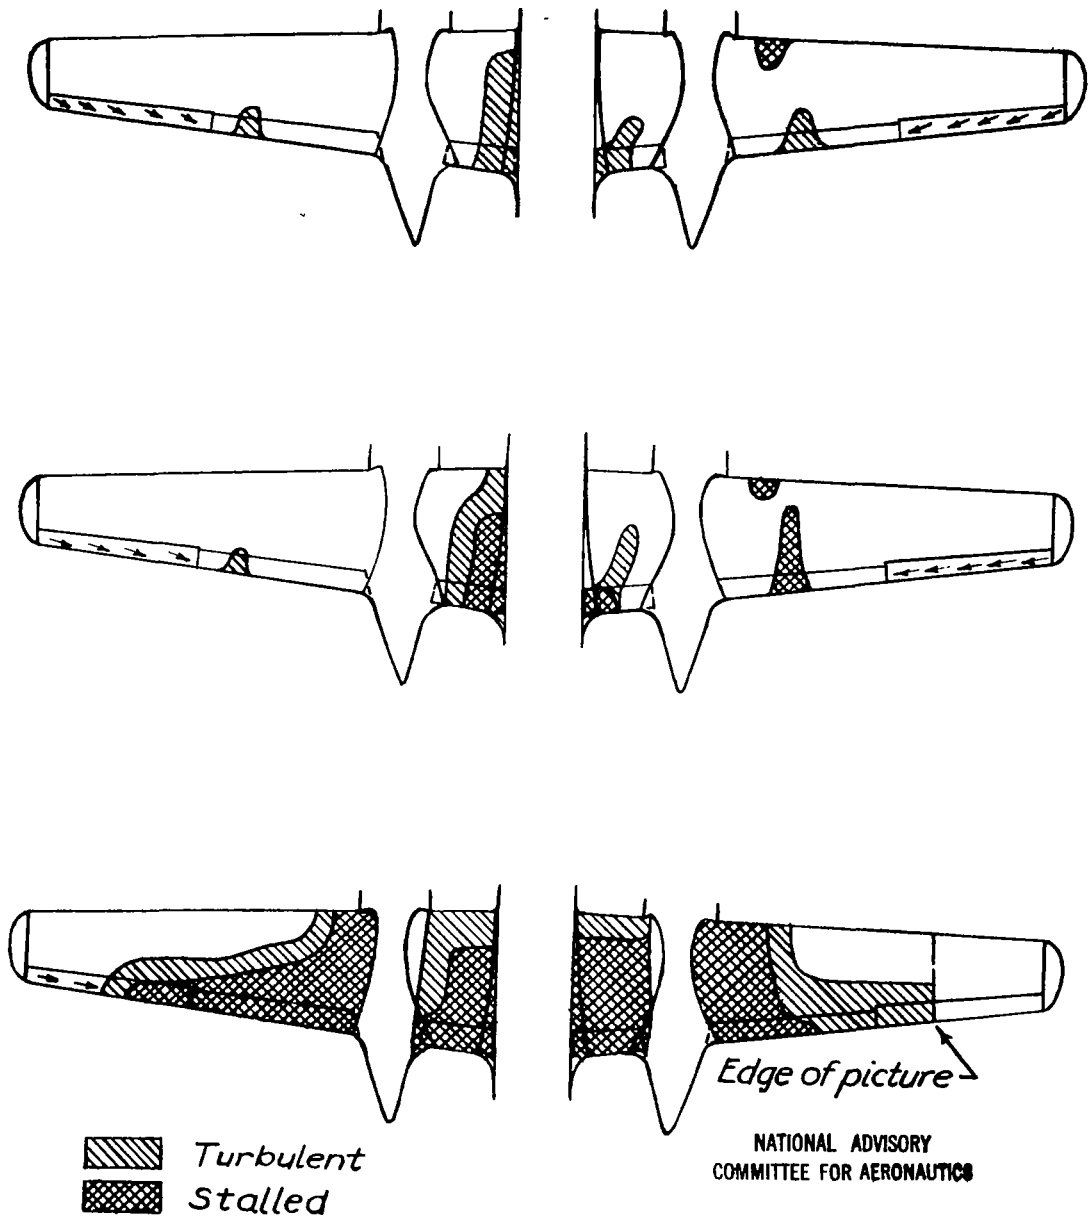
Figure 9.- Diagrams of stall progression in the gliding condition engines idling, flaps and landing gear up, cowl flaps closed, oil cooler one-half open), Douglas A-26B airplane.

2. The tuft studies (figs. 9, 10 and 11) show that root stall occurred. The root stall decreased the downwash at the tail and thus accounted for the increase in pull forces and up-elevator deflections required at the stall. A premature breakdown of flow over the right-wing duct lips was noted in the gliding condition, but this flow breakdown did not occur with the flaps down and probably would not occur with power on.

3. With engines idling, flaps up or down a pitching oscillation occurred at the stall. Figure 9 shows the stall pattern for the flaps-up, engines idling condition to be symmetrical. Because of the symmetrical stall pattern no abrupt rolling motions occurred. Recovery from the pitching oscillation could be promptly effected by application of down elevator.

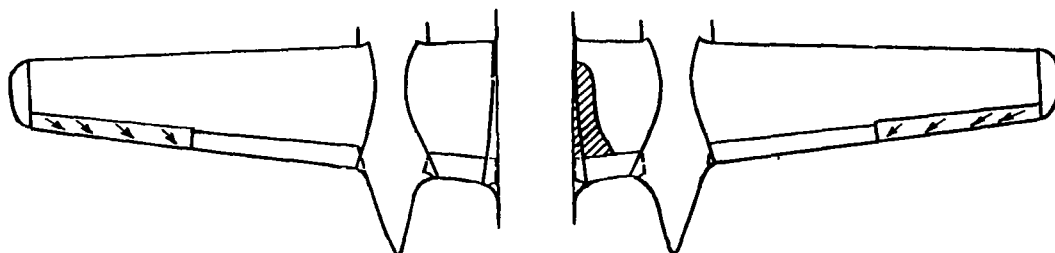
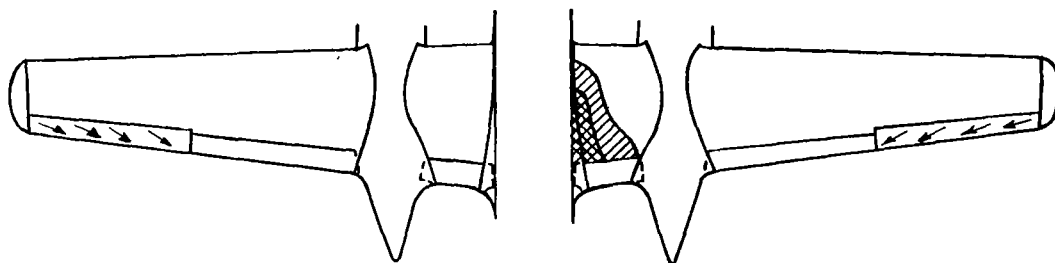
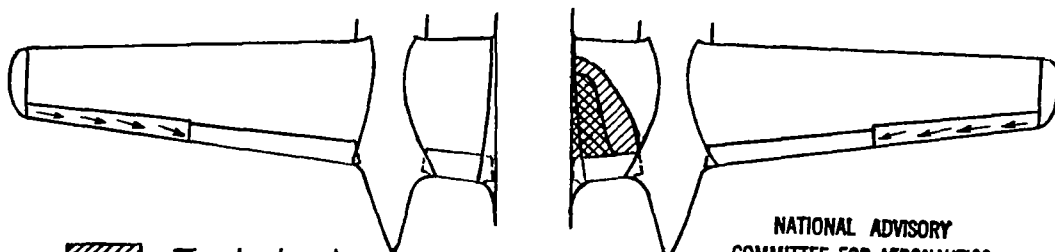
Left wing between nacelle and fuselage and right wing inboard flap not visible throughout run.

Figure 10.- Diagrams of stall progression in the landing condition (engines idling, flaps and landing gear down, cowl flaps closed, oil cooler one-half open), Douglas A-26B airplane.

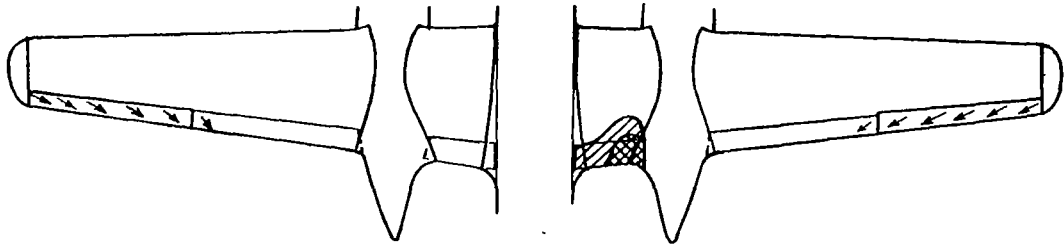
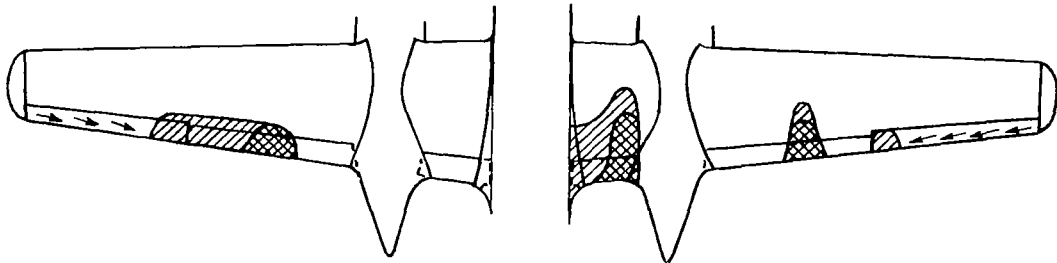
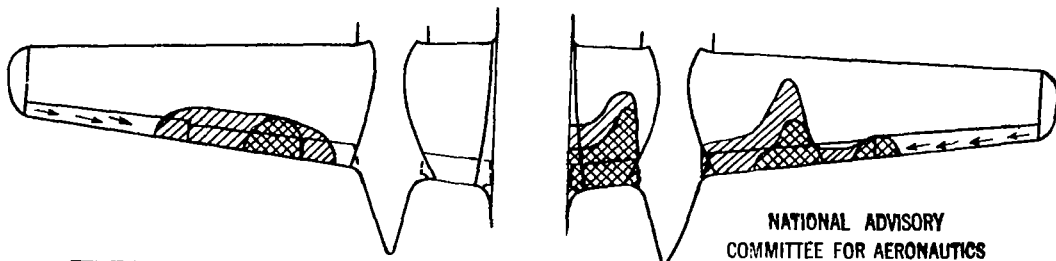
Left wing between fuselage and nacelle not visible throughout run

Figure 11.- Diagrams of stall progression with left propeller feathered, right engine delivering normal rated power, flaps and landing gear up, oil cooler one-half open), Douglas A-26B airplane.

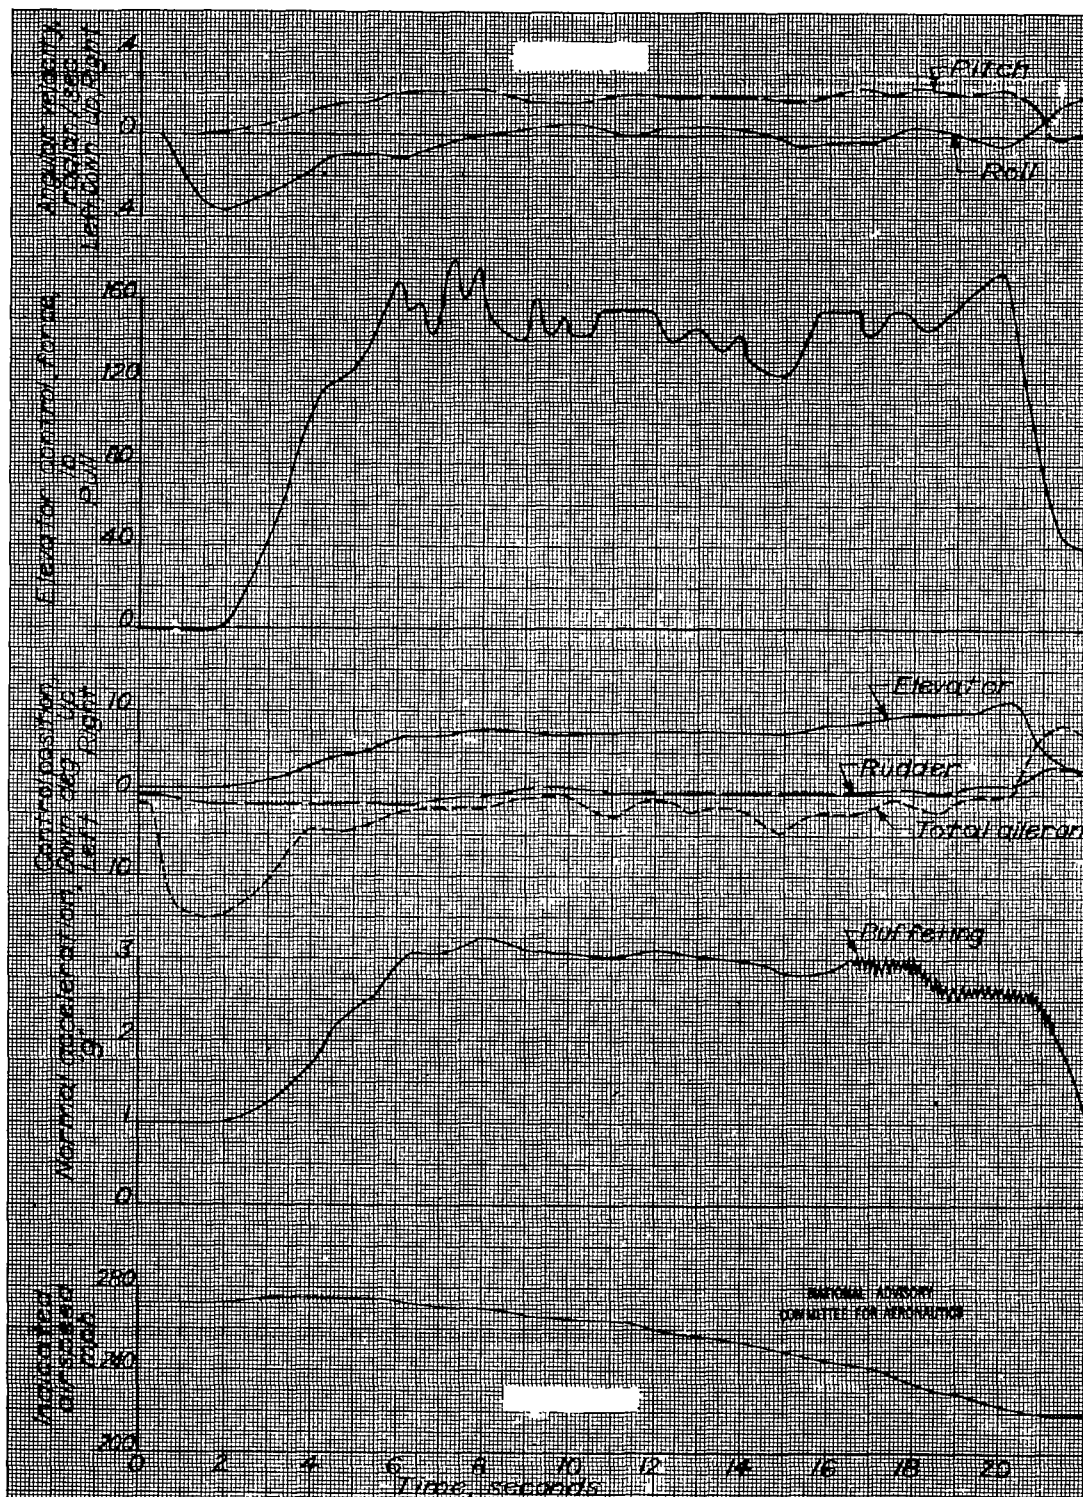
Figure 12.- Time history of a wind-up turn to the stall in the rated power, clean condition (41.5 in. Hg. at 2400 rpm, flaps up, landing gear up, cowl flaps closed, oil cooler one-half open), c.g. at 23 percent M.A.C., Douglas A-26B airplane.

The stalling characteristics in turning flight were investigated in the rated power-clean condition. In these tests the airplane was trimmed at the maximum speed for level flight and constant acceleration turns were made as the airspeed was gradually reduced to the stall warning. Figure 12 is a time history of a typical left turn in which this procedure was followed.

Good stall warning was again present in the form of buffeting, and recovery could be made by moving the elevator down.

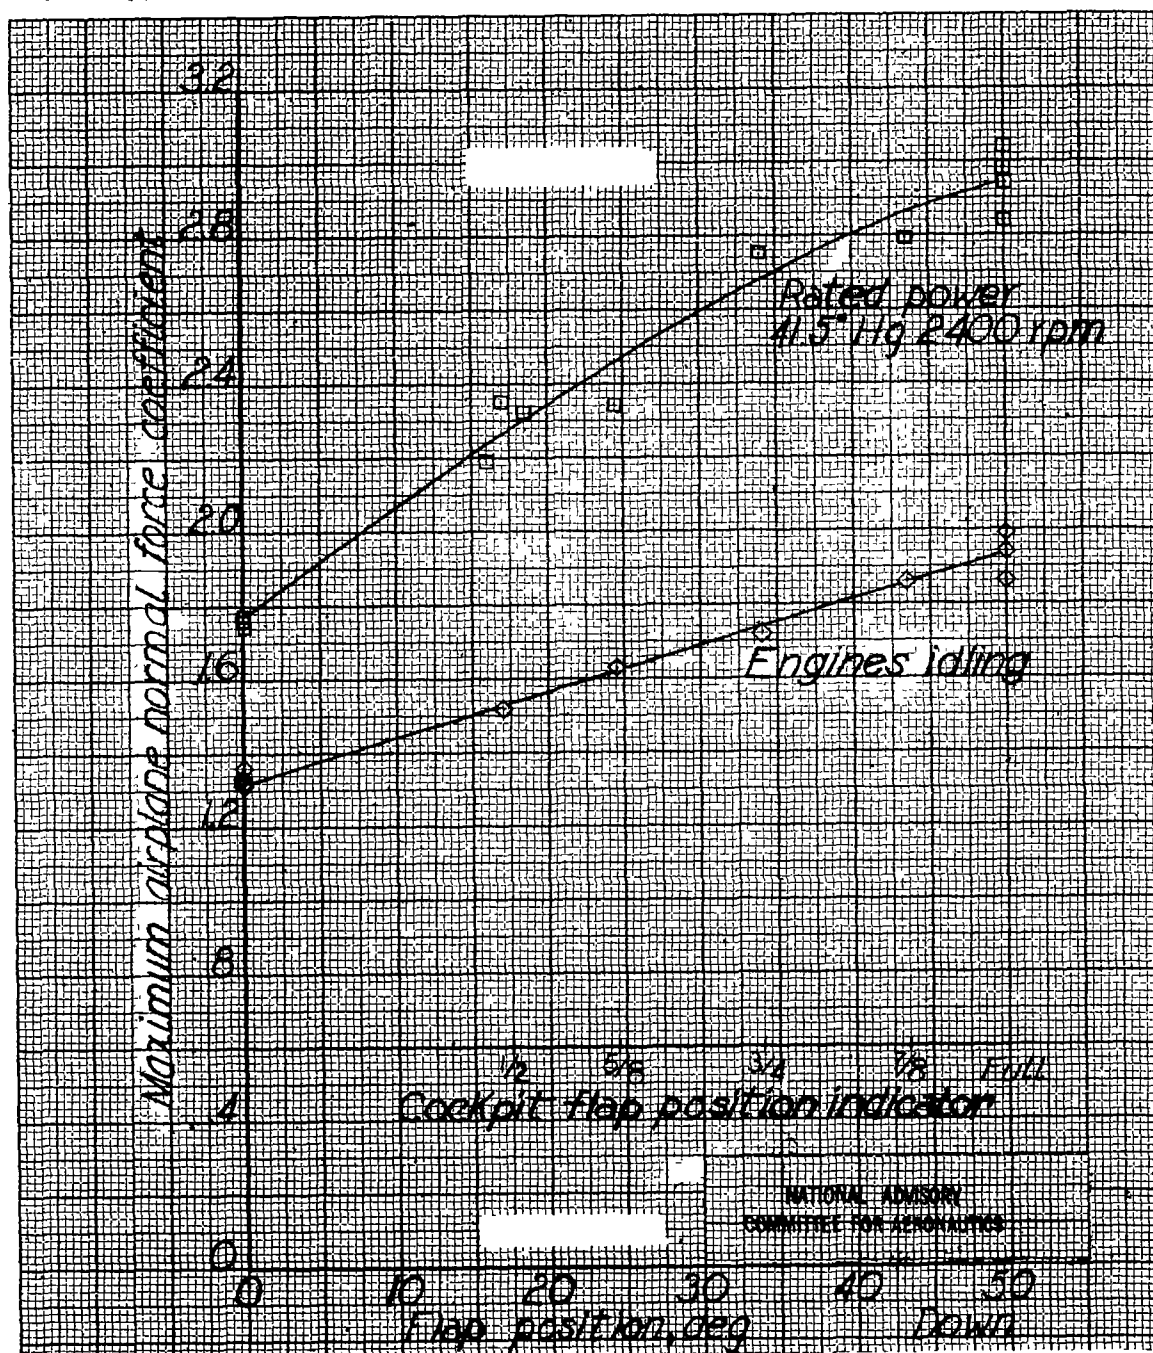
Figure 13.- Variation of maximum airplane normal force coefficient with flap position. Douglas A-26B airplane.

Table I presents the weights, center-of-gravity positions, and flap and landing-gear positions corresponding to the maximum normal-force coefficients obtained. Figure 13 shows the variation of maximum normal-force coefficient with flap angle with the engines idling and also with rated power.

With engines idling the average values of maximum normal-force coefficient obtained from several stalls were 1.32 with the flaps retracted and 1.94 with the flaps fully extended.

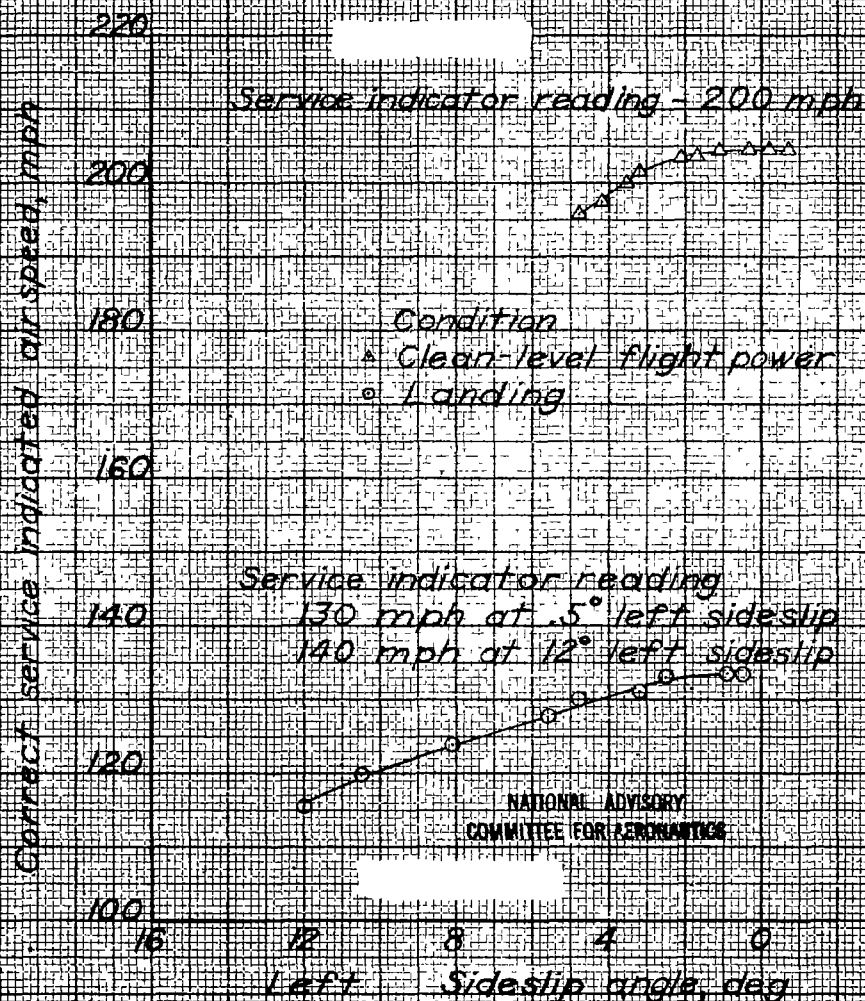
Figure 13.- Variation of correct service indicated airspeed with sideslip angle while the pilot attempted to hold a constant airspeed indicator reading in gradually increasing sideslips, Douglas A-26B airplane.

Figure 15 illustrates the large error in indicated airspeed due to sideslip at low speeds. At 140 miles per hour in the landing condition the service airspeed indicator read approximately 25 miles per hour high when the angle of sideslip was 12° . This error would probably be considerably reduced if the pitot-static head were mounted ahead of the wing tip instead of on the vertical tail. The pilot considered the sensitivity of the airspeed system to yaw objectionable especially during landings.
